Feasibility Report for

2021 Pavement Management Project

City of Cottage Grove, Minnesota

December 2020

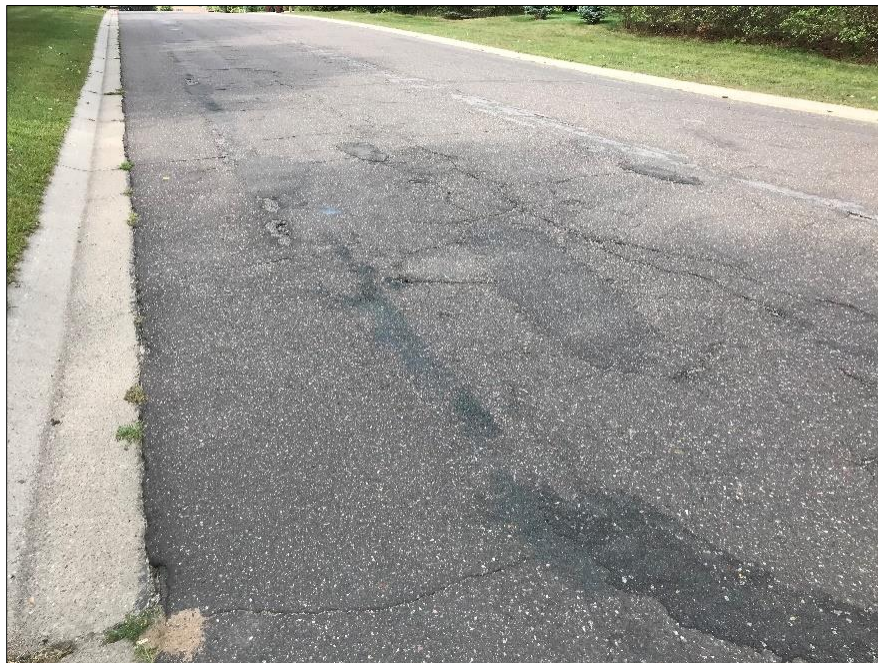
Approximate Location: 9998 85th Street

Reflective cracking through temporary skin patch overlay.

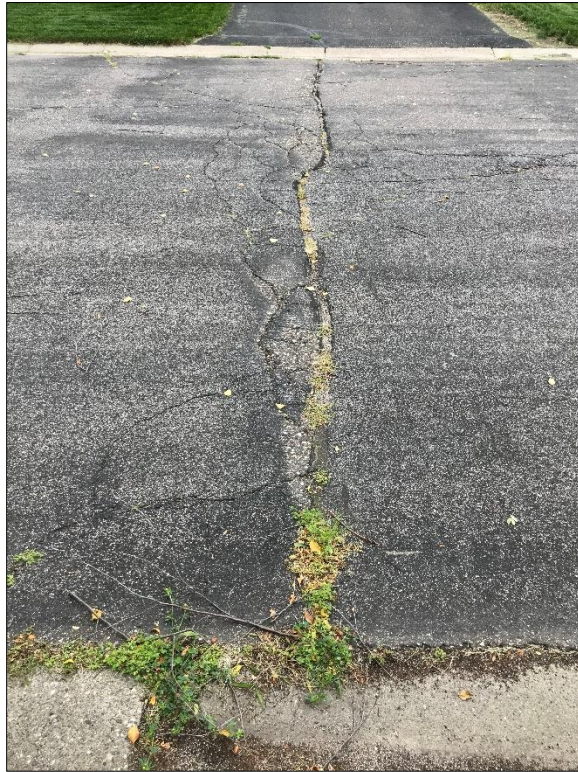
Approximate Location: 8732 Joliet Avenue

Fatigue/small block cracking adjacent to an open transverse joint.

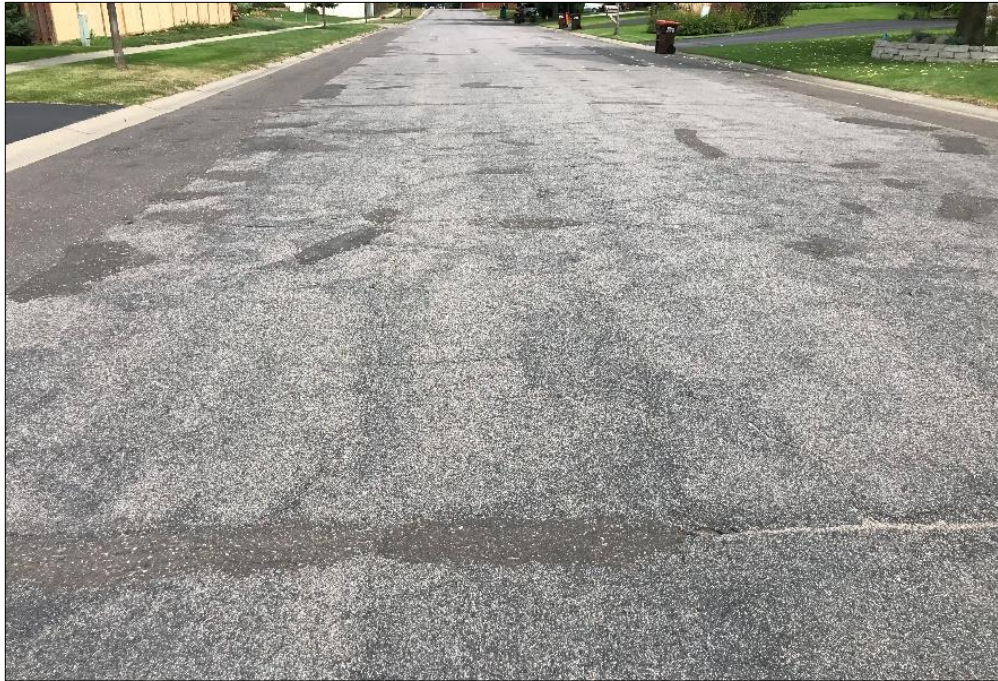
Approximate Location: 8689 Johansen Avenue

Thin overlay along the curb line to address asphalt stripping, numerous patch attempts and crack sealing present.

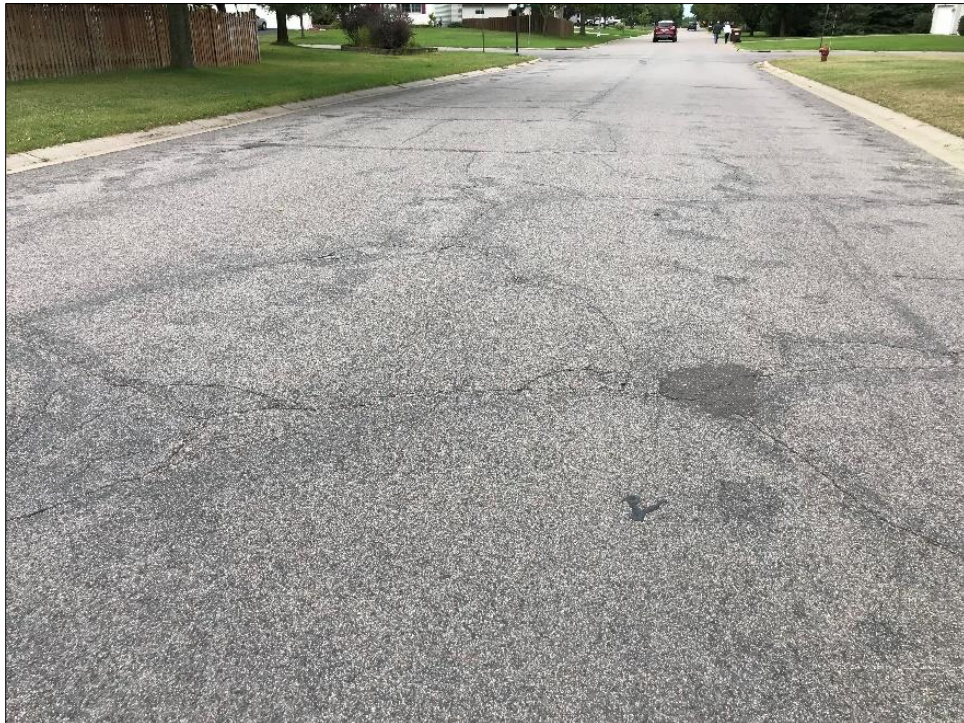
Approximate Location: 9553 Hillside Trail

Large block cracking typical throughout.

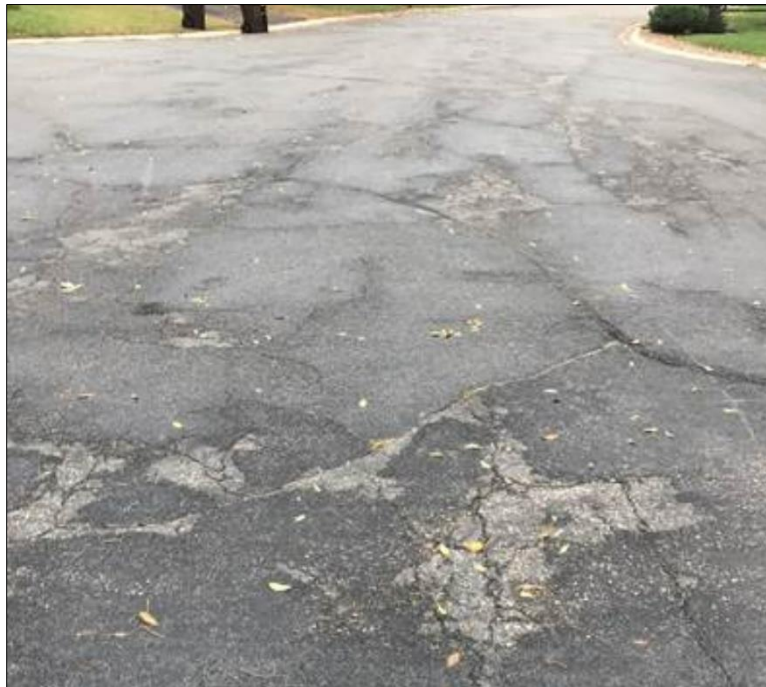
Approximate Location: 8279 Jeffery Avenue

This photo was taken in 2018 and depicts fatigue cracking, previous route and seal of cul-de-sac. This area has since been patched but the underlying condition is still present.

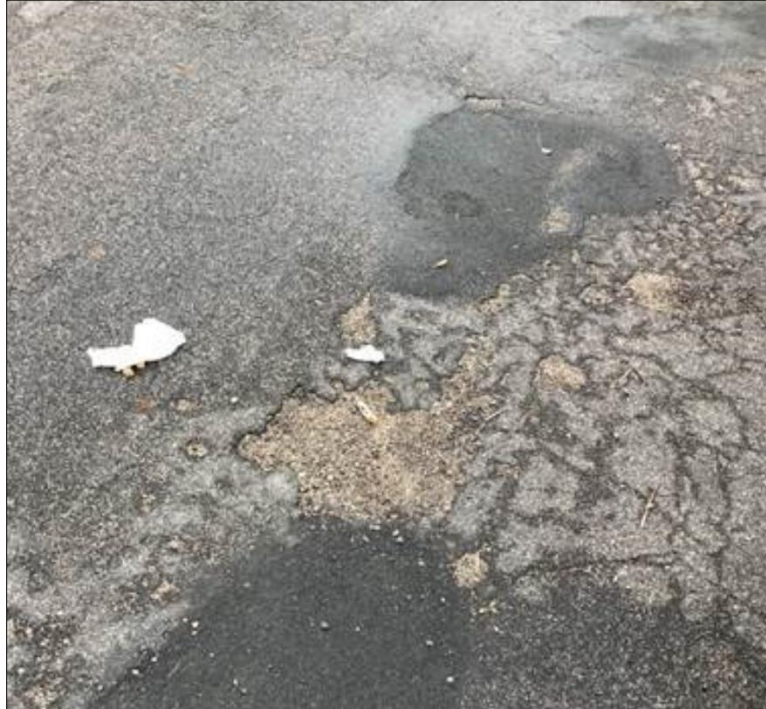
Approximate Location: 8236 Jeffery Avenue South

This photo was taken in 2018 and depicts severe asphalt stripping and previous attempts to patch. This area has since been patched but the underlying condition is still present.

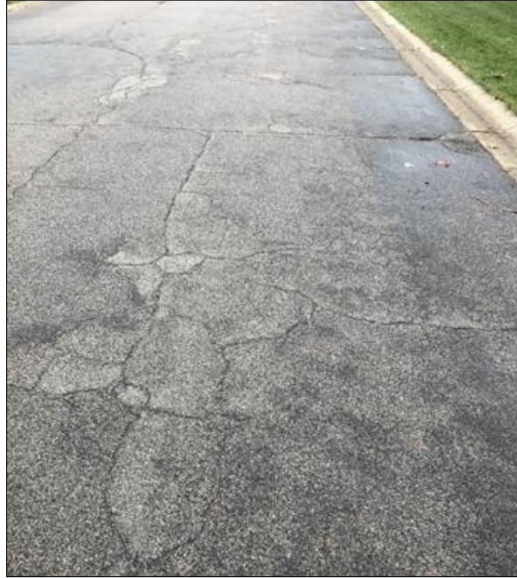
Approximate Location: 8033 Jeffery Lane

This photo was taken in 2018 and depicts typical block cracking and pavement fatigue in the neighborhood.

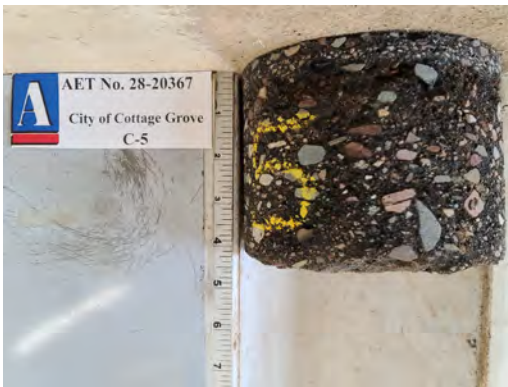
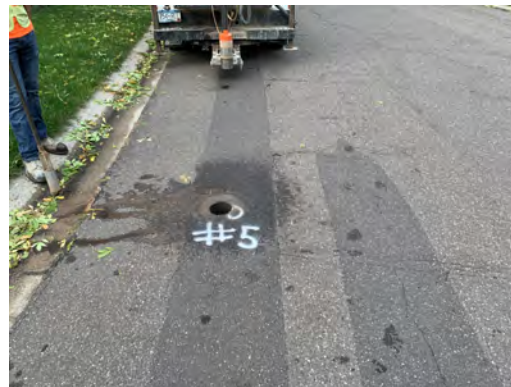
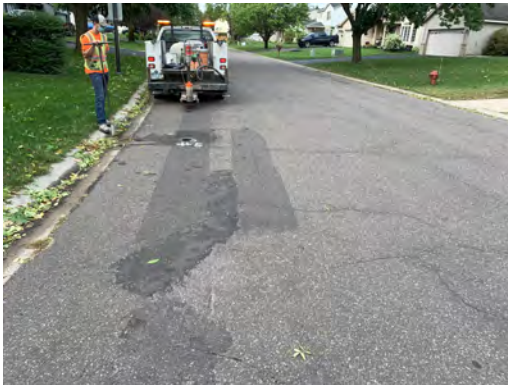
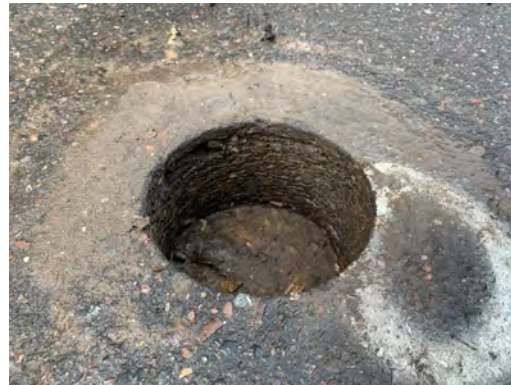
Comments :No visible lift thicknesses observed. Chip seal on surface and core showing minimal to moderate stripping throughout entire core.

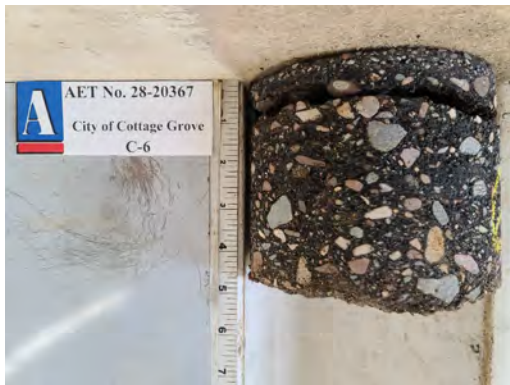
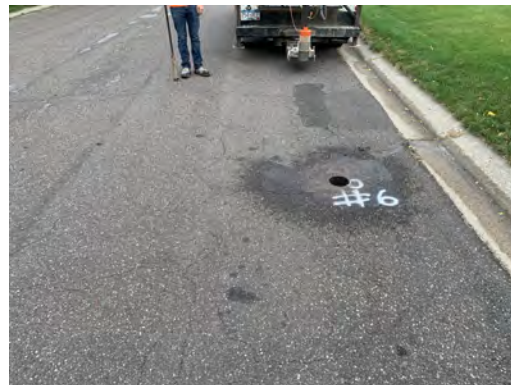
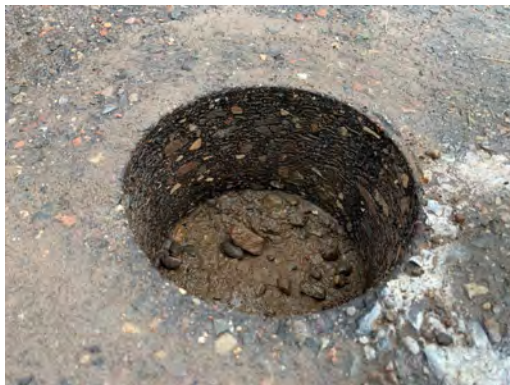
Comments :No visible lift thicknesses observed. Core broke at approximately 1" below the surface. Minimal stripping observed throughout entire core.

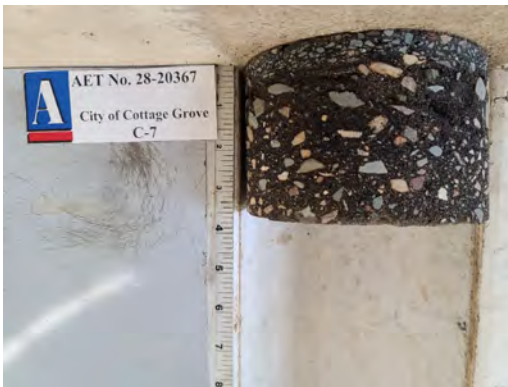
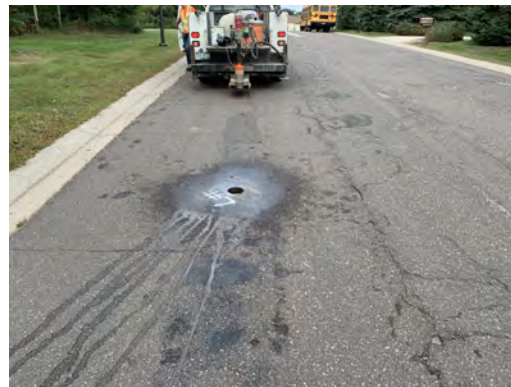
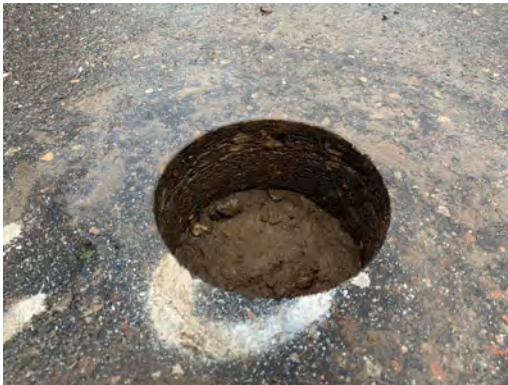
Comments :No visible lift thicknesses observed. Minimal to moderate stripping observed throughout entire core.

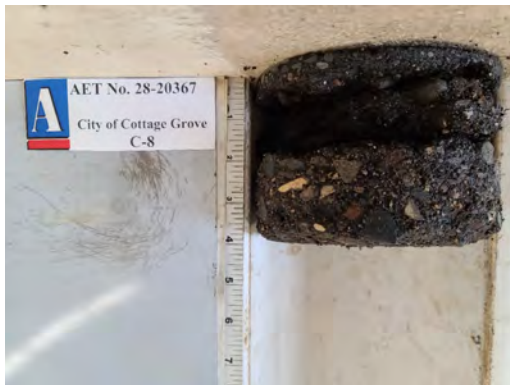
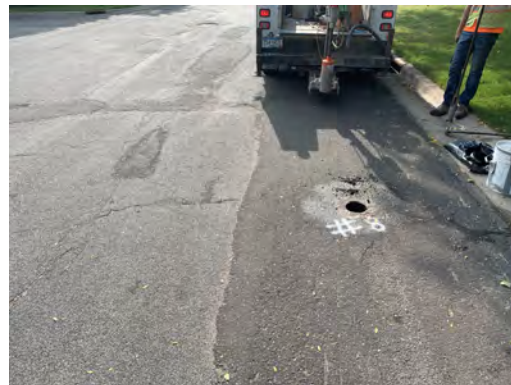
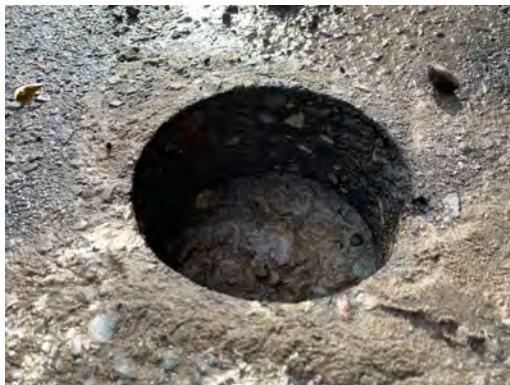
Comments :No visible lift thicknesses observed. Core broke at two places in the upper 2" of the core. Severe to moderate stripping throughout entire core.

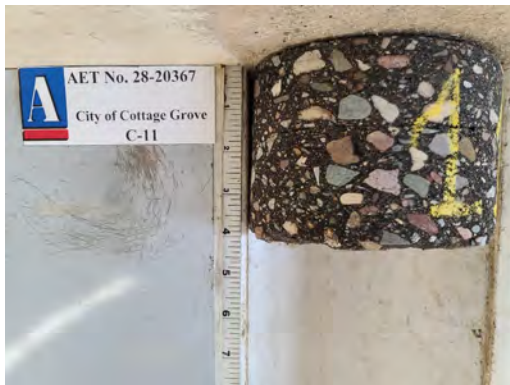
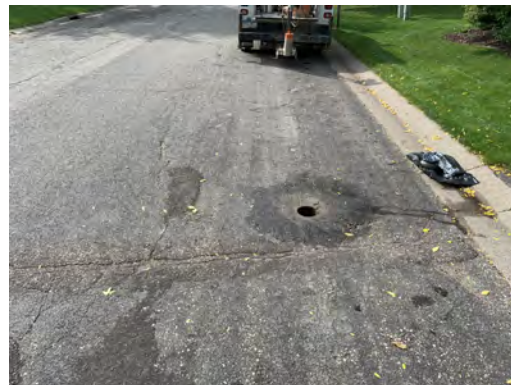
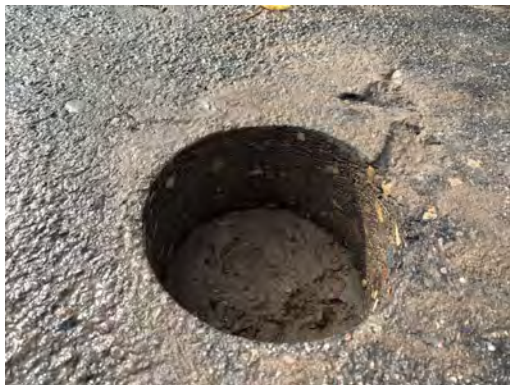
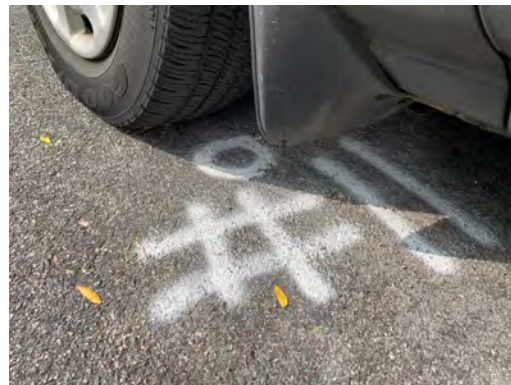
Comments :From surface of core down, Lift 1: 1.75", Lift 2: 2.25". Chip seal on surface and minimal stripping observed throughout entire core.

The core location was moved approximately 20 feet south due to a car that was parked in the location of the core that was marked.

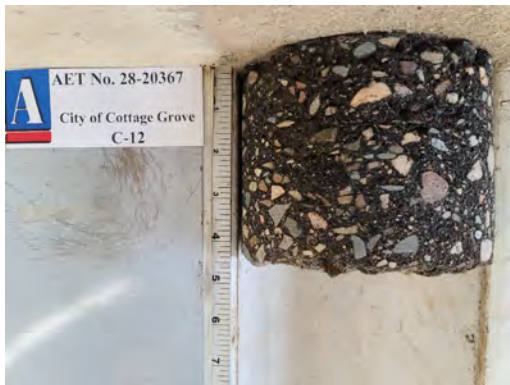
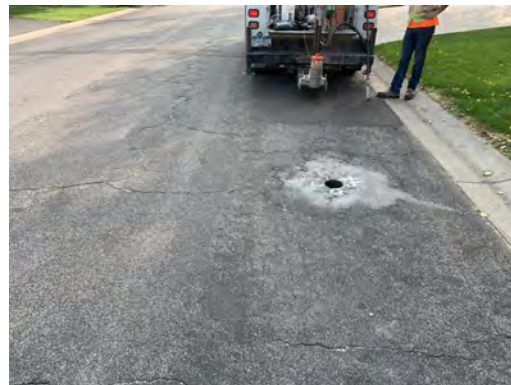
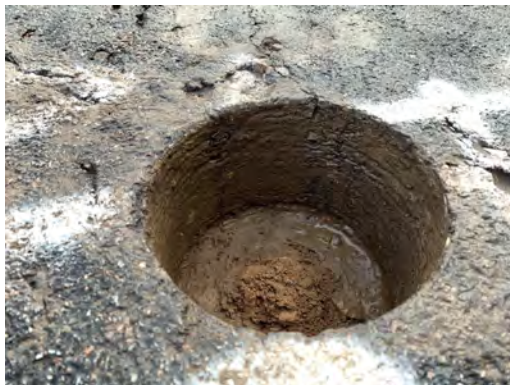
Comments :From surface of core down, Lift 1: 1.75", Lift 2: 2.6". Chip seal on surface and minimal to moderate stripping observed throughout entire core.

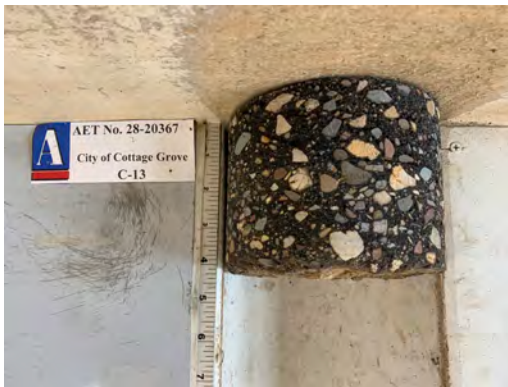
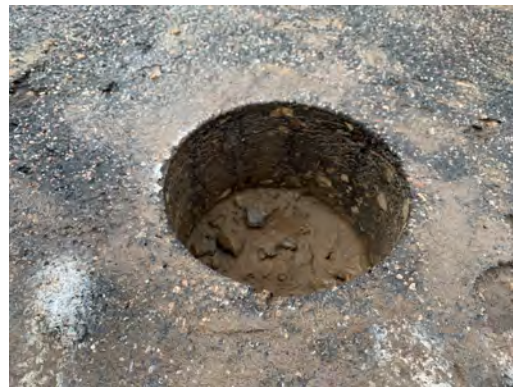
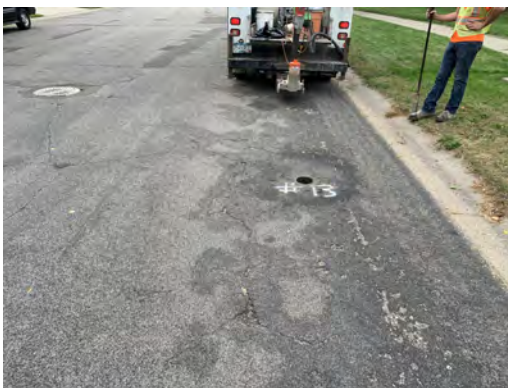
Comments :From surface of core down, Lift 1: 1.75", Lift 2: 2.25". Chip seal on surface and minimal stripping observed in top lift.

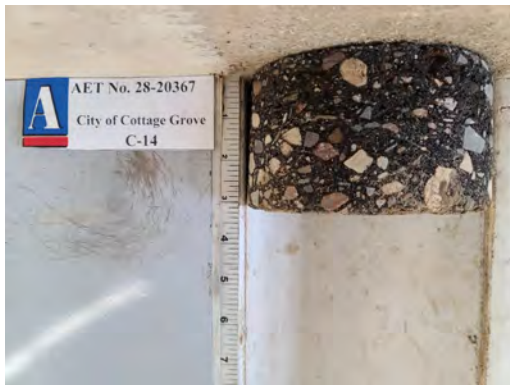
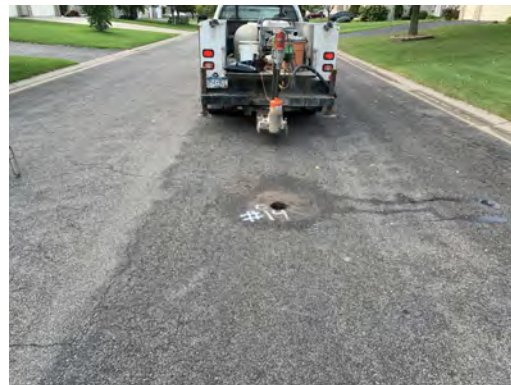
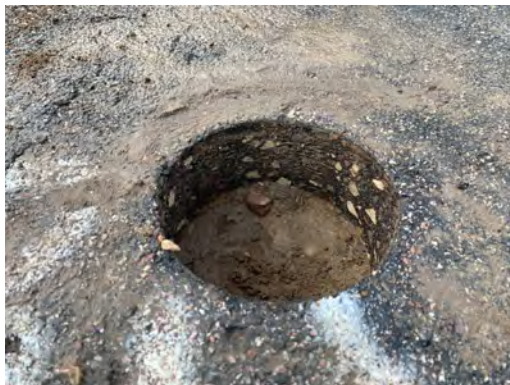
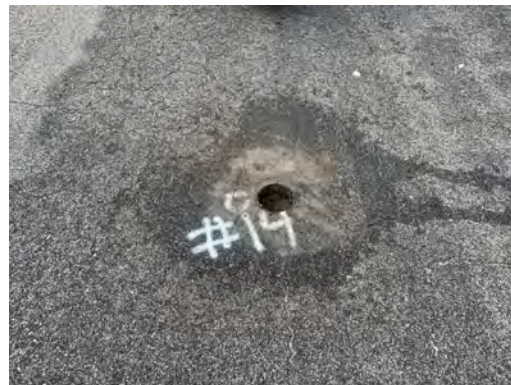
Comments :No visible lift thicknesses observed. Chip seal on surface and minimal stripping throughout entire core.

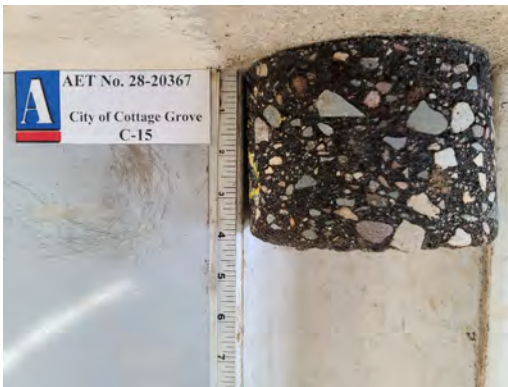
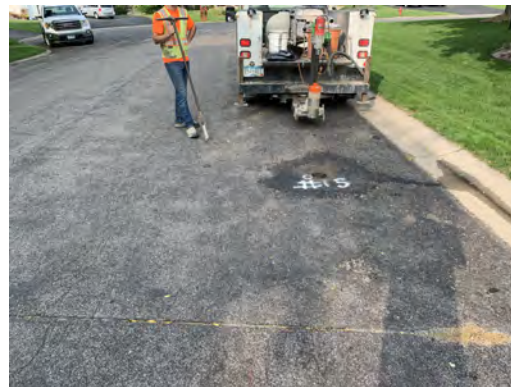
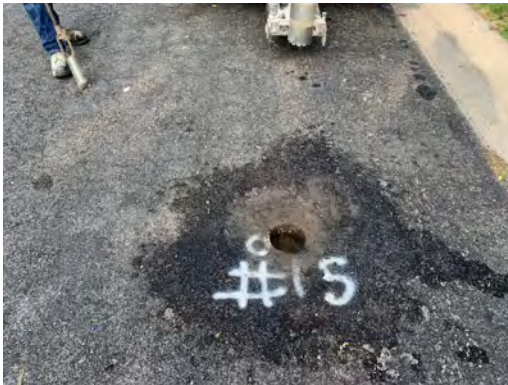
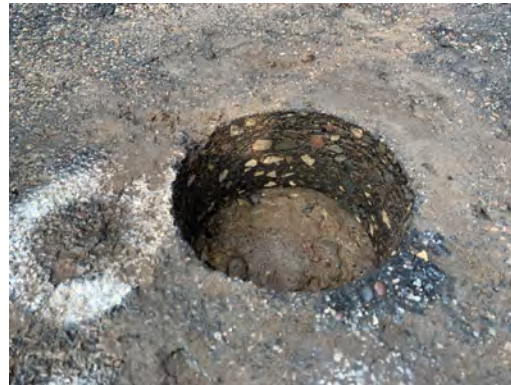
Comments :From surface of core down, Lift 1: 2.0", Lift 2: 1.85". Moderate to minimal stripping observed throughout entire core.

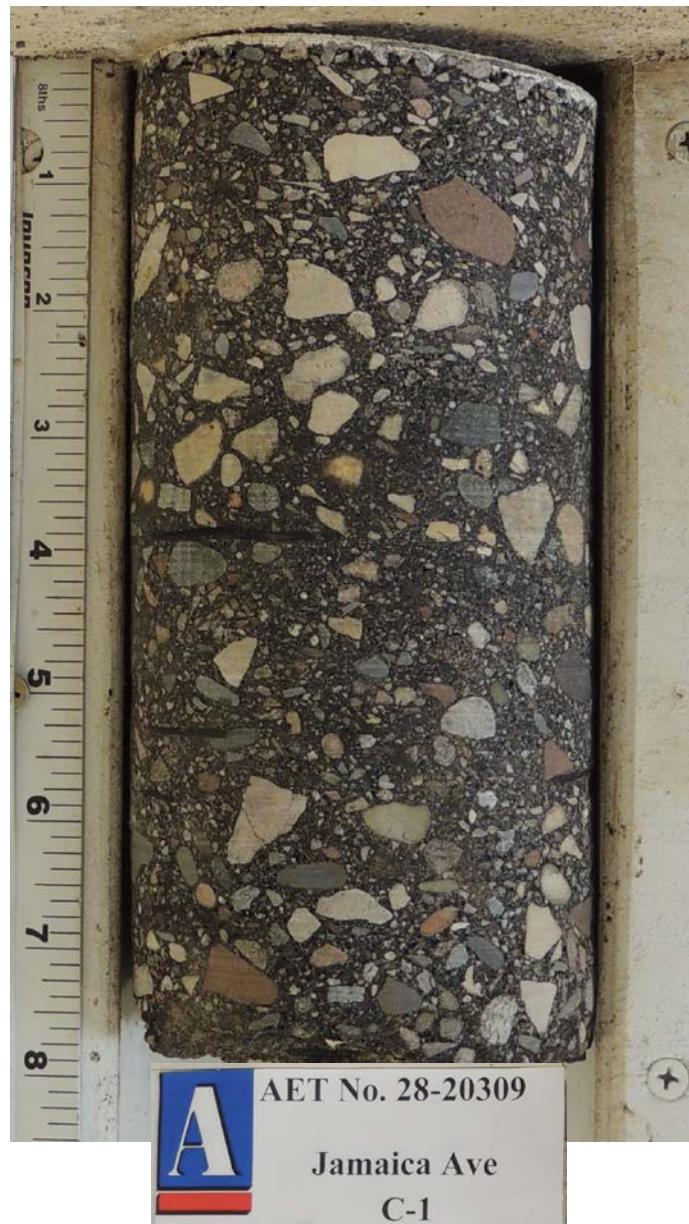
Possible chip seal at the surface.
Core contains slight stripping
throughout. Lift 4 contains slight
to moderate stripping.

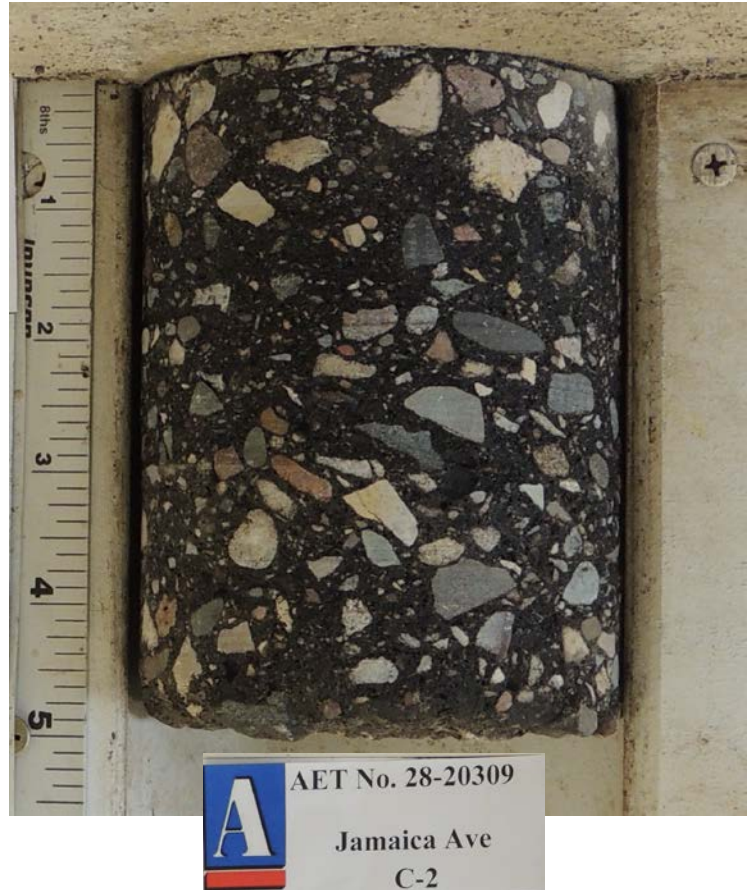
Possible chip seal at the surface.
Core contains moderate stripping throughout.

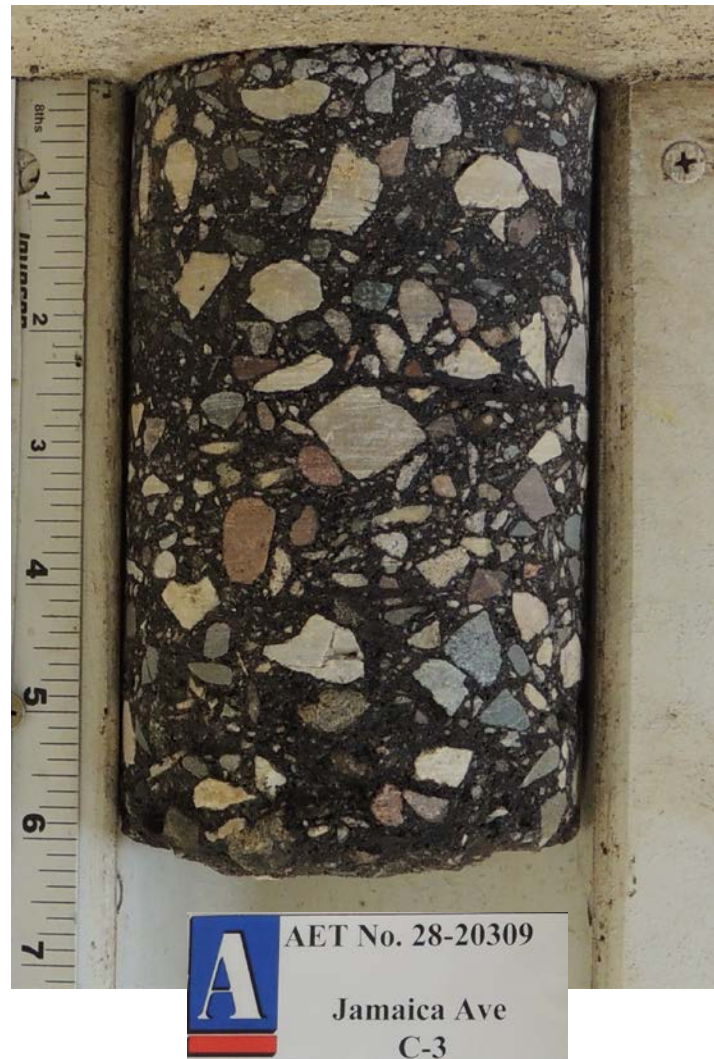
Possible chip seal at the surface.
Core has slight to moderate stripping throughout.

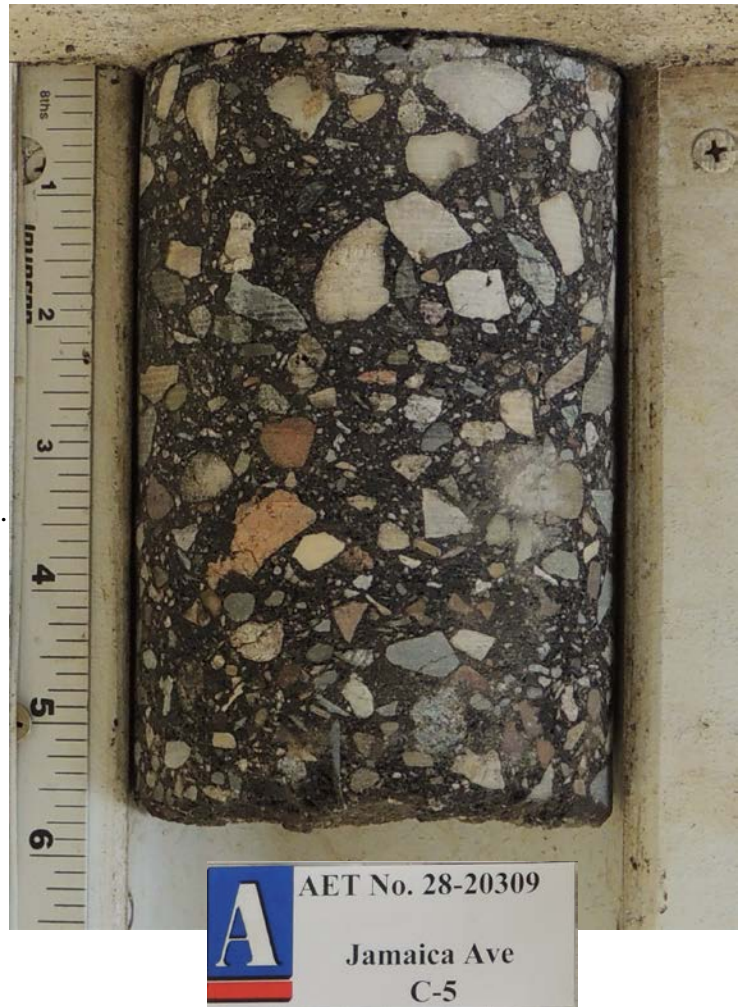
Lifts 1 and 2 contains slight stripping.

Lift 3 contains moderate stripping.

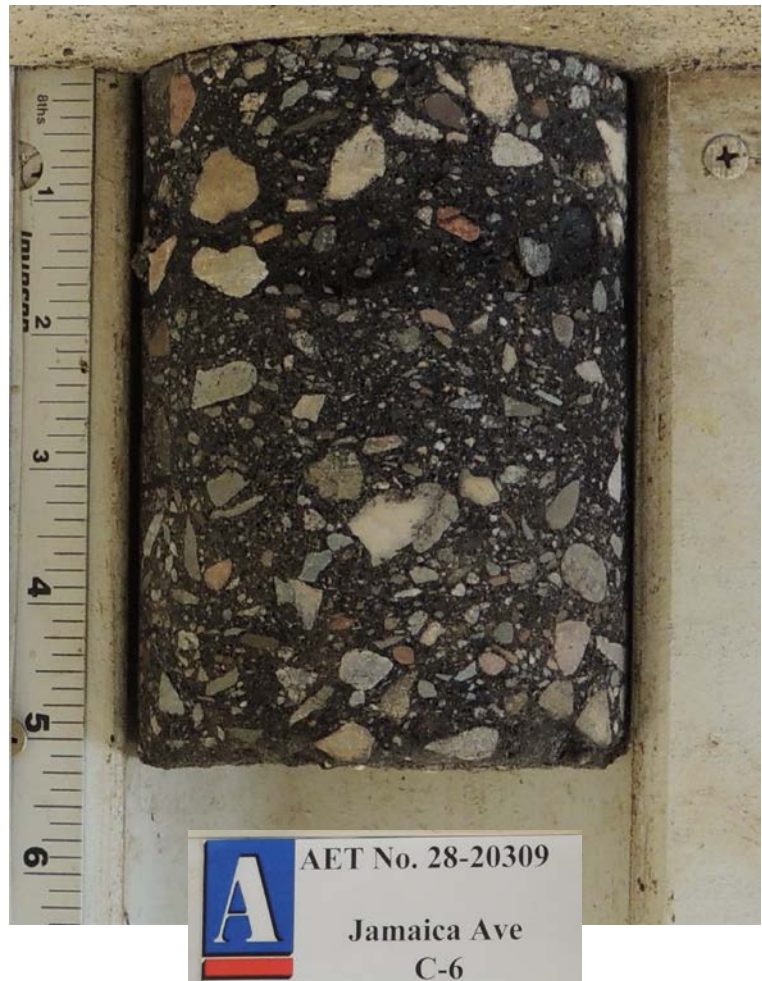
Possible chip seal at the surface.

Lift 1 contains moderate to severe stripping. Bottom of lift 1 contained large voids. Lifts 2 and 3 contains slight to moderate stripping.

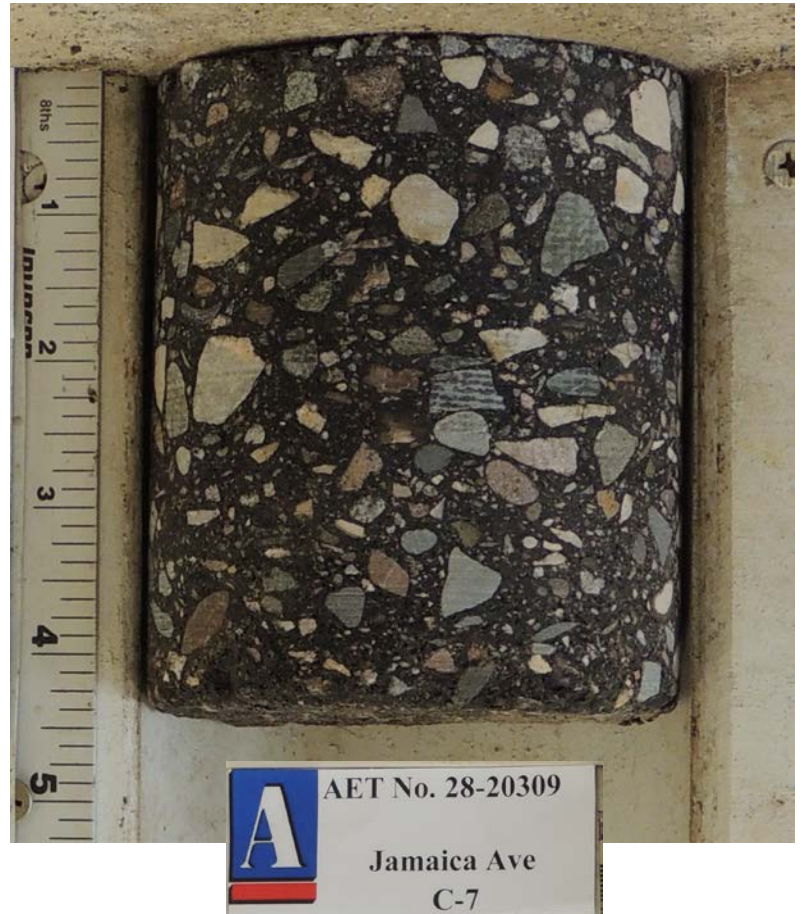
Possible chip seal at the surface.
Core generally has slight to moderate stripping throughout.

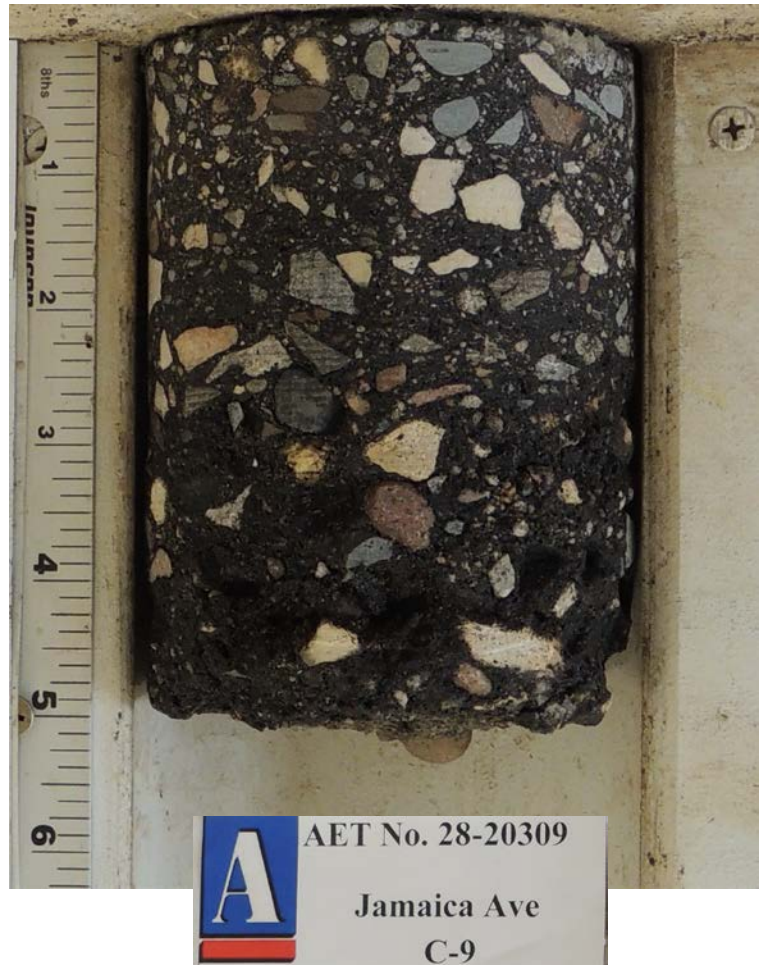
Lift 2 contains moderate stripping.

Lift 3 contains severe stripping
and large voids.

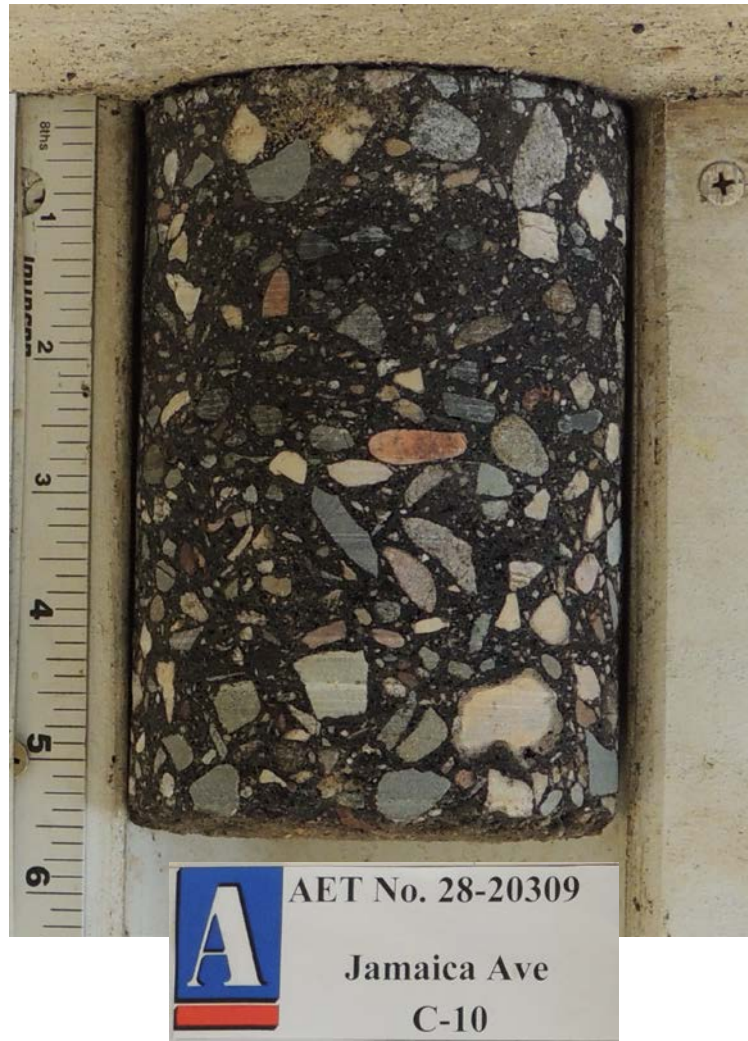
Possible chip seal at the surface.
Core contains moderate stripping throughout.
