Type & Boundary Application

Le Sueur Economic Development Authority

City of Le Sueur, Le Sueur County, Minnesota

WETLAND DELINEATION REPORT

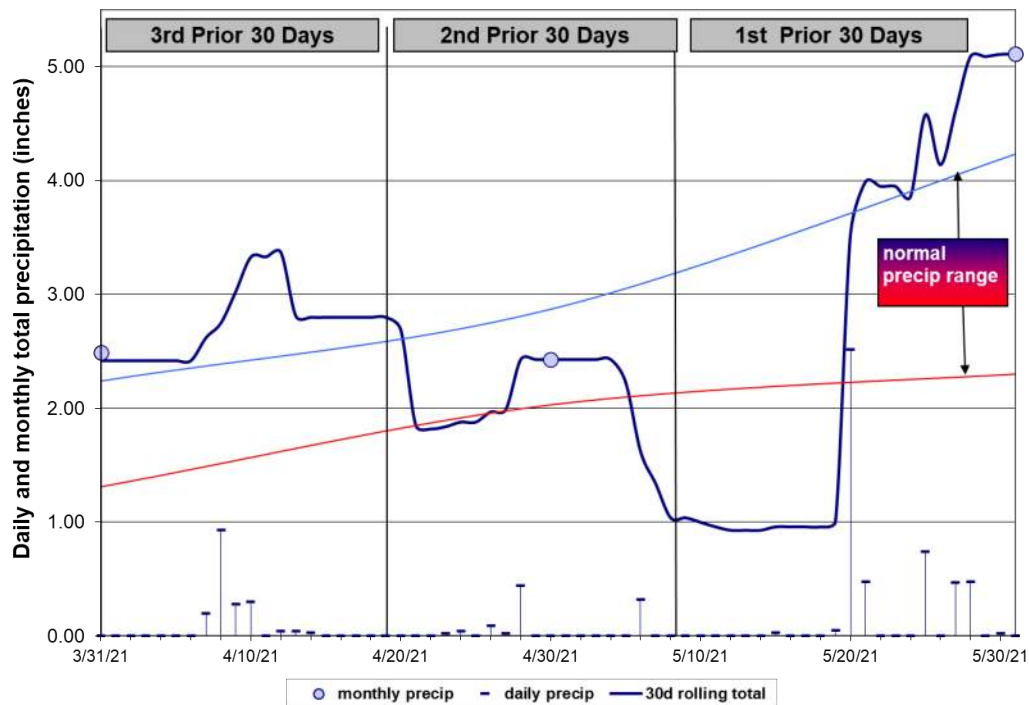
ANTECEDENT PRECIPITATION CONDITIONS

Antecedent precipitation was evaluated using a combination of the NRCS Method and the Rolling Totals Method. The analysis found that precipitation was well above normal at the time of site visit, over the last three months prior to site visit precipitation was variable.

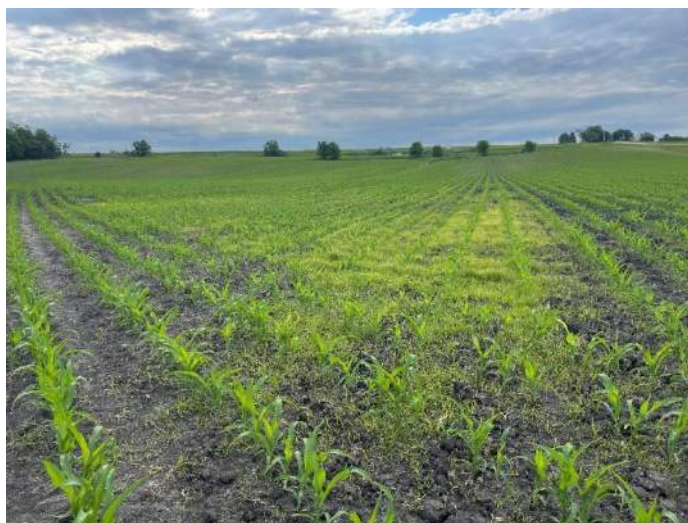
Wetland 1 is a shallow basin at the bottom of a hillside. A Seasonally Flooded Basin is found in the north-center section of the study area. Water flows downhill through drainage feature 1 and continue to runs off-site into an unnamed channel (Tributary 1).

The field investigation found that the site has met all three wetland indicators and this wetland should be considered a palustrine emergent nonpersistent seasonally saturated (PEM2B). Two sample points were taken to determine the wetland boundary. The wetland boundary was largely drawn based on the changes in topography as vegetation was disturbed by agricultural row crops.

Photo 1: View of Wetland 1 looking East.

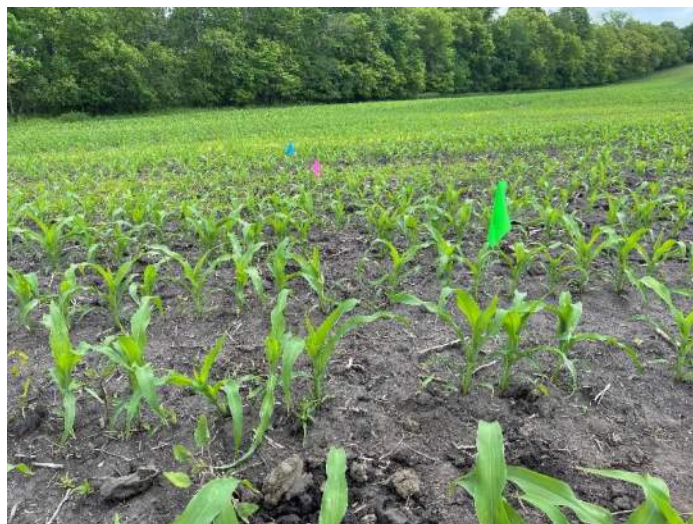
Soils in the W1-A wetland pit location met the hydric soil indicators A11-Depleted Below Dark Surface and A12-Thick Dark Surface. Soils in the W1-B upland pit location met the hydric soil indicators A11-Depleted Below Dark Surface and A12-Thick Dark Surface. Both pit locations met hydric soil indicators.

The W1-A wetland location met the secondary hydrology indicators of B6-Surface Soil Crack, C6-Saturation Visible on Aerial Imagery & D2-Geomorphic Position. The W1-B upland pit location only met one secondary indicator of B6-Surface Soil Crack. Only the wetland pit location met hydrology indicators.

Photo 2: View of the W1-A (blue flag) & W1-B (green flag) sample points looking into the wetland. The pink flag is the wetland boundary.

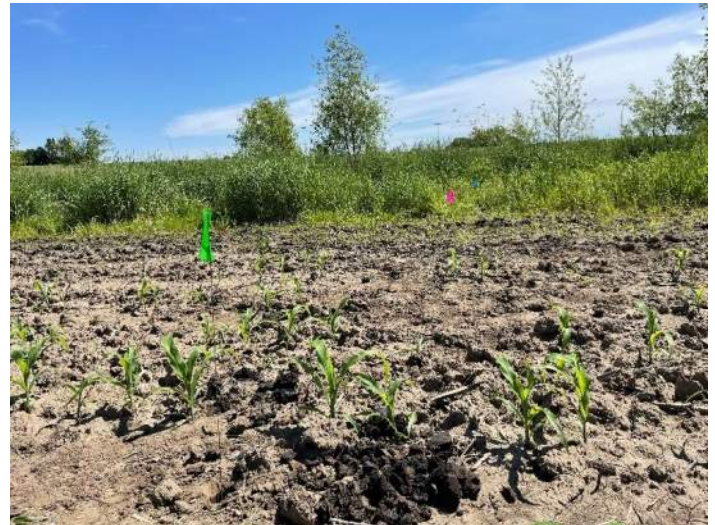
Wetland 8 is a strip of fringed wetland along a drainage feature that flows west downhill.

The field investigation found that the site has met all three wetland indicators and this wetland complex should be considered a palustrine emergent persistent seasonally saturated (PEM1B). Two sample points were taken to determine the wetland boundary. The wetland boundary was largely drawn based on the changes in topography.

Photo 4: View of the W3-A (blue flag) & W3-B (green flag) sample points looking west at transect. Pink flag is the wetland boundary.

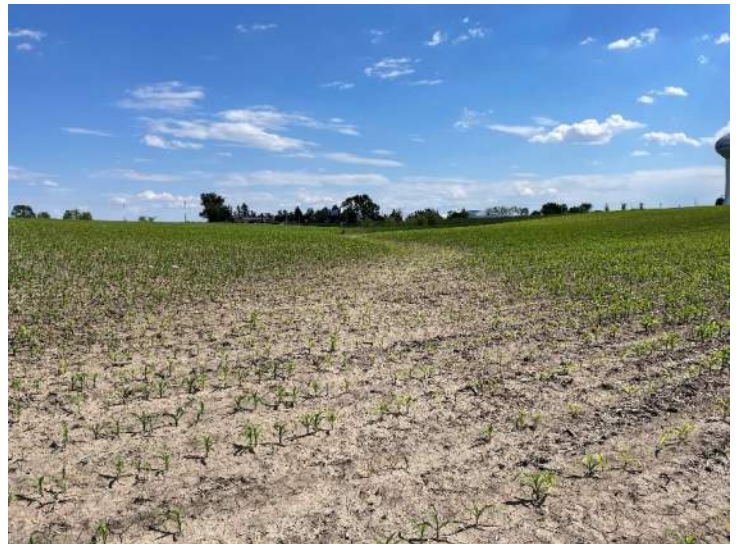
Site 2 is found just west of Drainage Feature 1, in a large depressional basin that continues to flow to Tributary 2. This was area found in the off-site as a potential site to investigate for wetlands.

Site 2 did meet two secondary indicators of hydrology, B6- Surface Soil Crack & D2-Geomorphic Position. Site 2 did meet indicators of wetland hydrology.

Even though hydric soil and wetland hydrology was present, there was no hydrophytic vegetation to make this a wetland. Site 2 is not a wetland.

Photo 5: View of site 2 looking into Drainage Feature 1

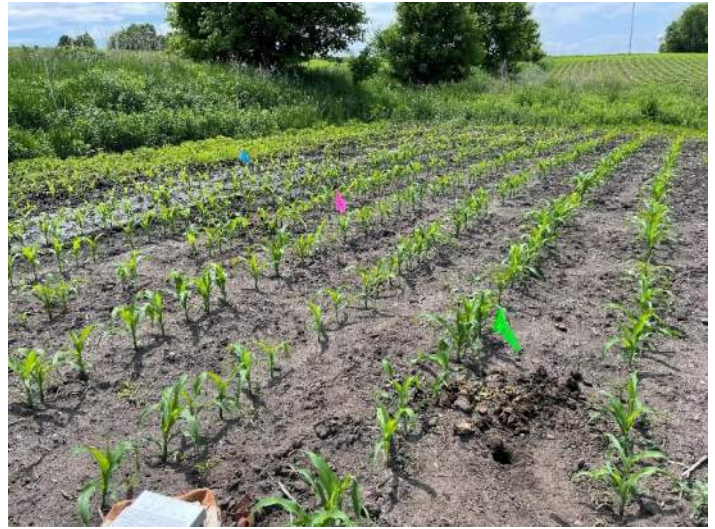
Site 5 is found in the North-east section of the study area. Drainage feature 1 flows just south of the sampled area. This area was assumed to be a fringed wetland from the drainage feature but further investigation proved to be not a wetland system.

The site 5 pit location did meet hydrology indicators by meeting two secondary indicators, B6-Surface Soil Crack and D2-Geomorphic Position.

Photo 6: View of investigation of site 5. Blue flag is where soil boring occurred.

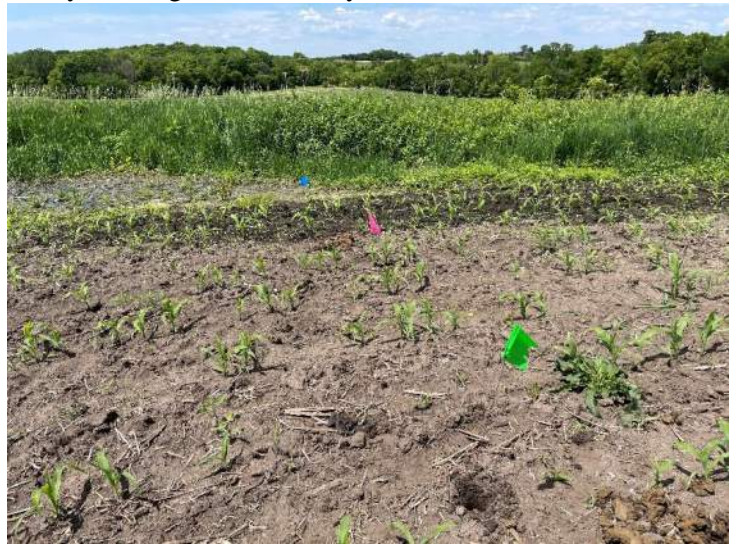
Site 6 is found just east of site 1 and is higher in elevation by a bit but there was sitting water on the landscape so was an indicator to possible wetland.

The site 6 did meet hydrology two secondary indicators of B6-Surface soil crack and D2-Geomorphic Position.

Even though hydrophytic vegetation and hydrology indicators were met, this site is not a wetland because of the lack hydric soil.

Photo 7: View of investigation of site 6. Blue flag is where soil boring occurred.

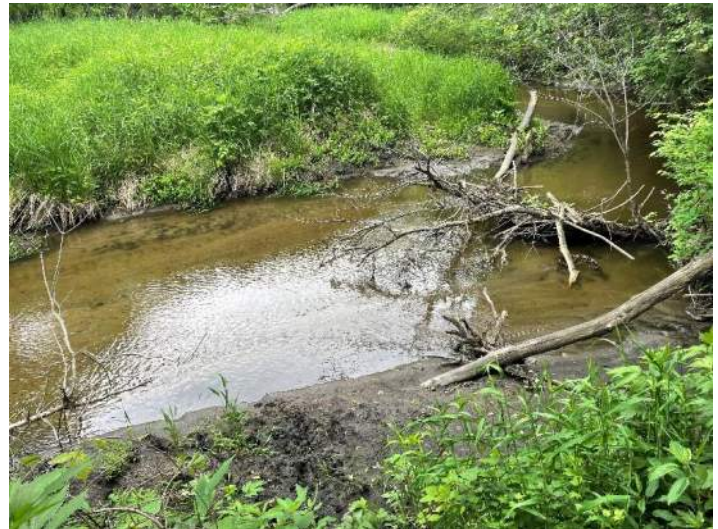
Photo 8: View of Tributary 1 unnamed channel (DNR hydro ID: 124050).

The Unnamed Channel sample point was taken from observations along the northern boundary of the study area. The channel flows North to south and weaves in and out of the study area. On the southern part the bank is very steep while on the northern section the bank is less steep. Water on the landscape runs from east to west flowing from agricultural fields into a variety of tributaries or drainage features to then flow into Unnamed channel. This area is not a wetland because of the defined unvegetated bed and bank that is present in the channel. Hydrology from the Unnamed Creek will continue south and flow off site into the Minnesota River. At this sample point, the tributary was approximately 3-feet wide from the top of bank, with an OHWM width of approximately 6-feet. Bank heights of the creek were approximately 2-feet tall on either side, with a water depth of approximately 6-inches or less.

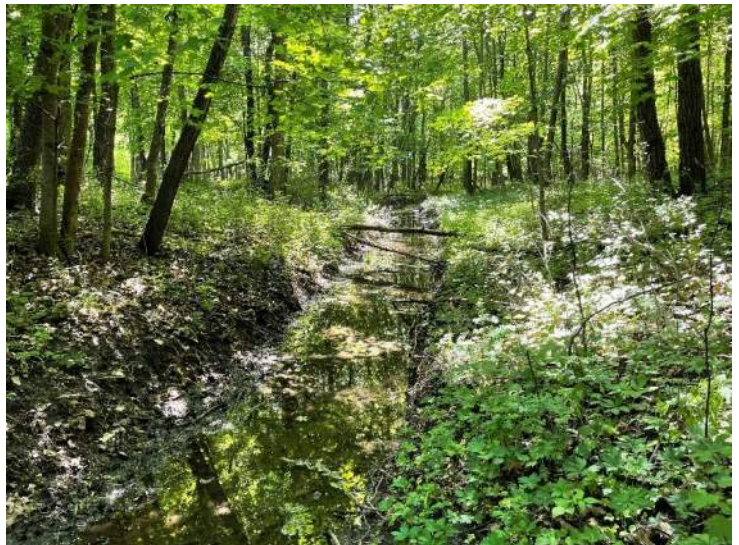
Photo 9: View of Tributary 2

This tributary starts with a culvert from tiled farm field and weaves through the NWI (PFO1A) and eventually will flow offsite and meet with Tributary 1 to continue south to flow into The Minnesota River. At this sample point, the tributary was approximately 1-foot wide from the top of bank, with an OHWM width of approximately 5ft. This area is not a wetland because of the defined unvegetated bed and bank that is present in the channel. Bank heights of the creek were less than 1-foot tall on either side, with a water depth of approximately 6-inches or less.

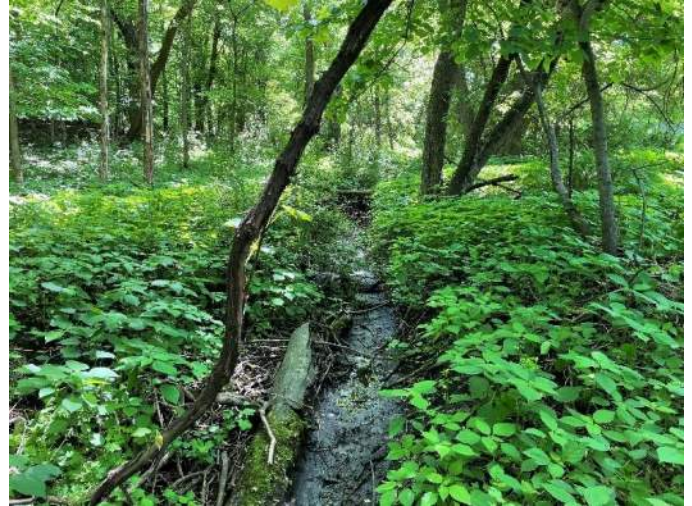
Tributary 3 has two forks that flow through a non-wetland forest and slowly flow down into wetland 2 before flowing into tributary 1. This area is not a wetland because of the defined unvegetated bed and bank that is present in the channel. At this sample point, the tributary was 2-feet wide at top of bank, with an OHWM of approximately 3-feet across. Bank heights of the creek were approximately 1-foot tall on either side, with a water depth of approximately 6 inches or less.

Photo 10: View of Tributary 3

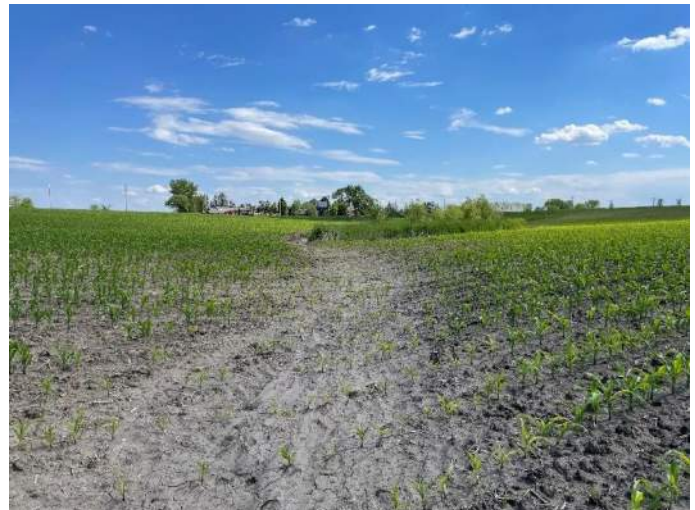
Photo 11: View of Drainage feature 1

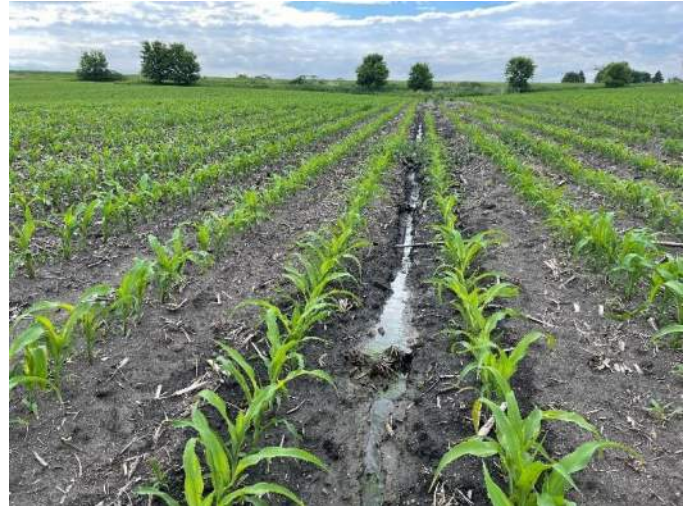
Photo 12: View of drainage feature 2

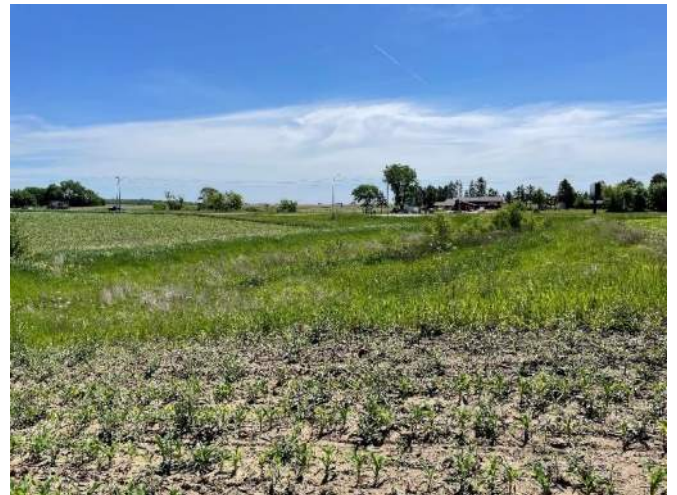
This infiltration basin was built in 2016, originally on an upland location. The purpose of the basin was to provide stormwater treatment for improvements made to the water tower site.

Photo 13: Stormwater Pond looking east.
