Feasibility Report for

2021 Pavement Management Project

City of Cottage Grove, Minnesota

December 2020

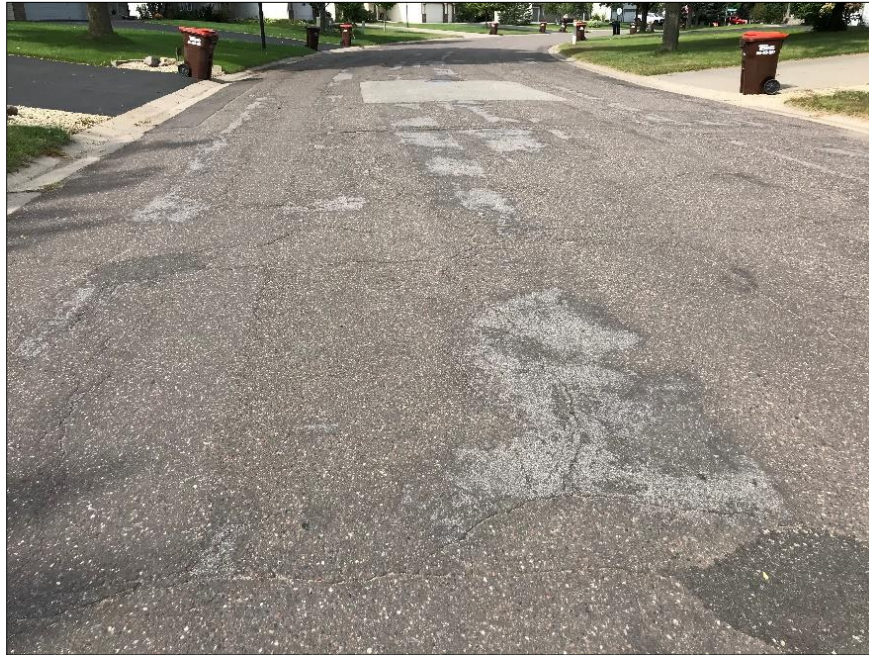
Approximate Location: 9821 85th Street

Temporary skin patch overlay across entire width of road performed in 2010. Additional patching has since occurred, and original distresses have reflected through.

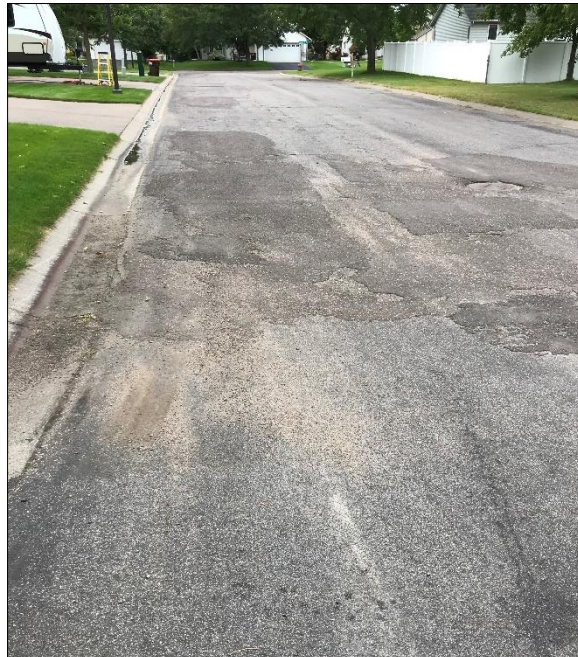
Approximate Location: 8719 Jorgensen Avenue

Curb and gutter settlement and resultant poor drainage evident; numerous street patches present.

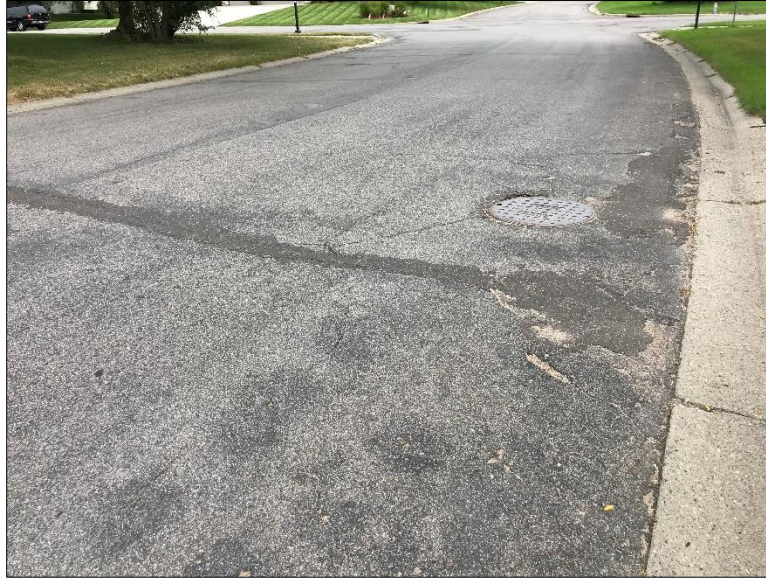
Approximate Location: 9589 Hillside Trail

Asphalt stripping along the curb line; previous patching attempts evident.

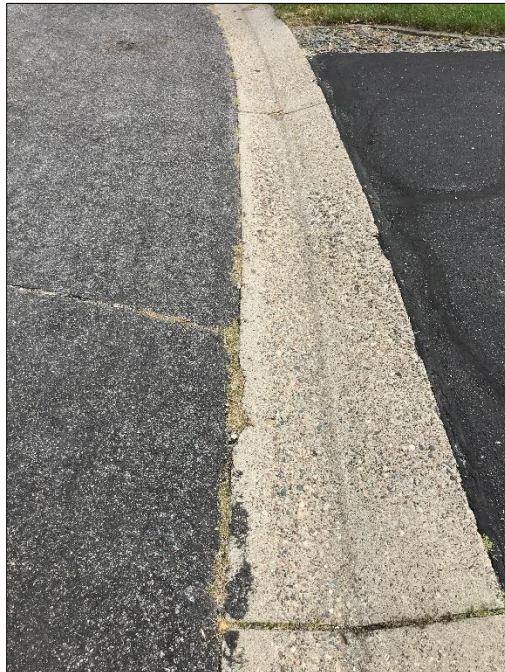
Approximate Location: 8241 Jeffery Lane

Functional concrete curb and gutter, although exposed aggregate surface appearance.

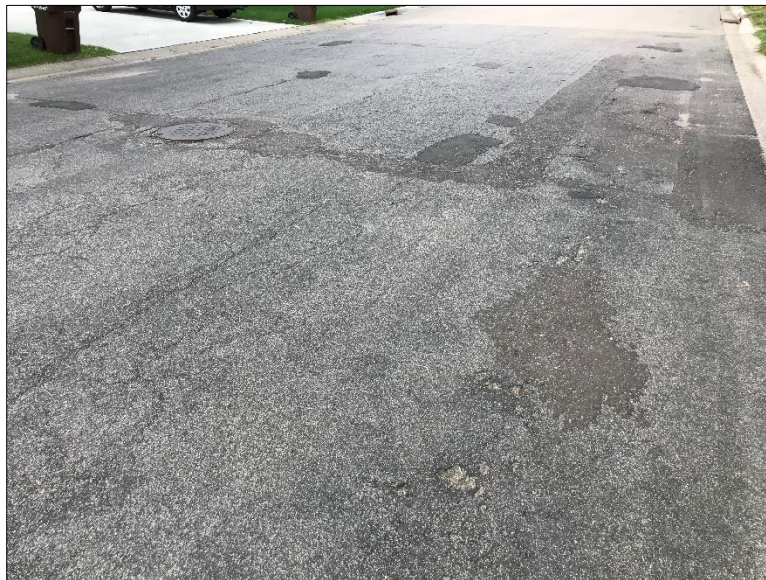
Approximate Location: 9063 Upper 81st Street

Asphalt stripping and associated patching attempts.

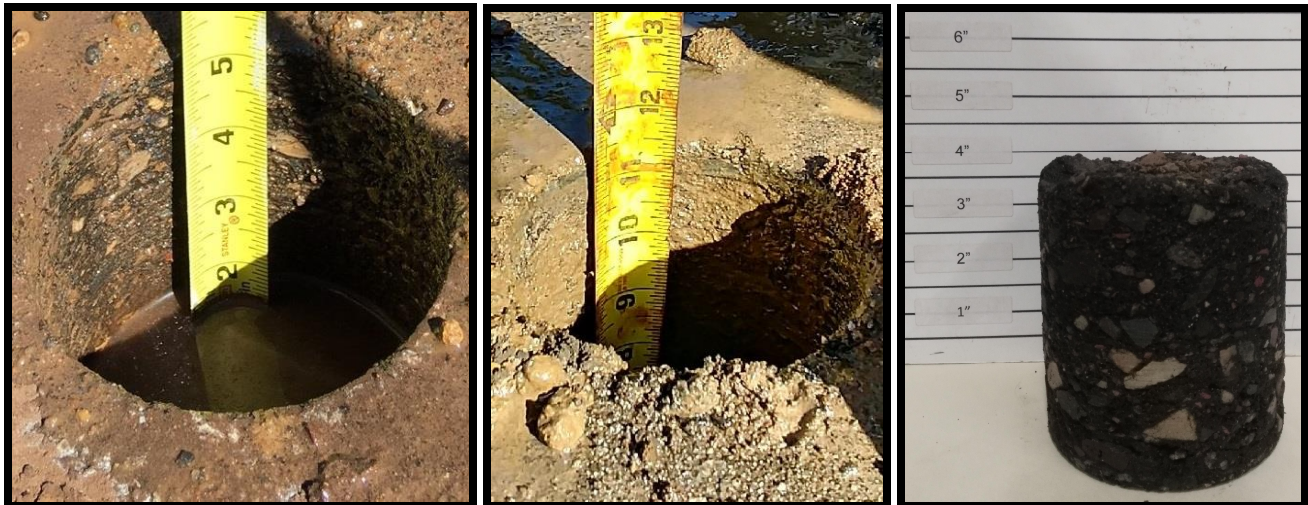
*Coring Location C-4**

*NTI's Field Technicians disturbed the aggregate base beneath the road with the coring drill barrel. The displaced materials were removed from the hole and the core prior to these pictures. This incident accounts for the discrepancy between the hole and core dimensions.

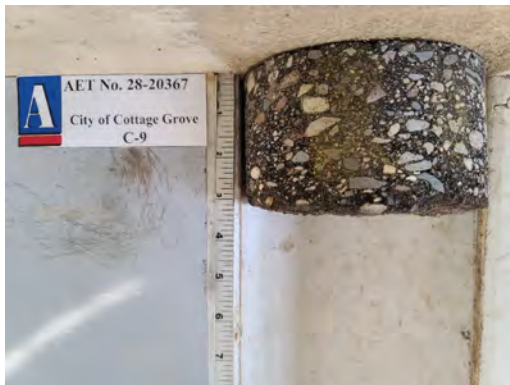
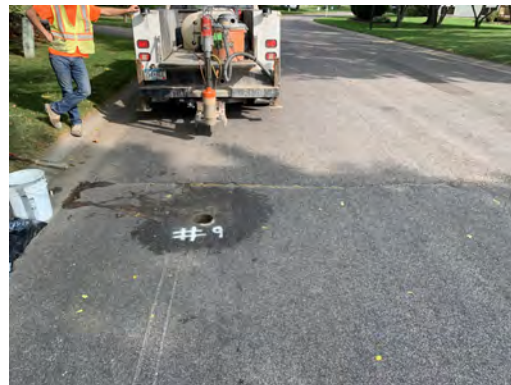
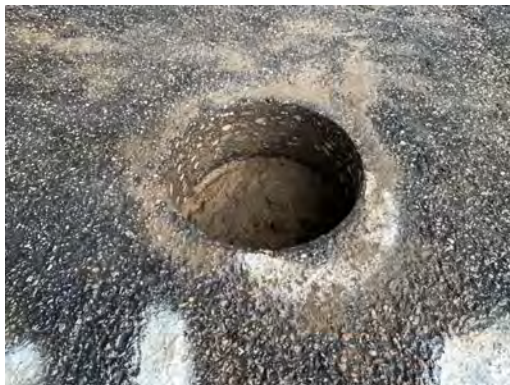
Comments :From surface of core down, Lift 1: 1.3", Lift 2: 1.8". Core generally solid throughout.

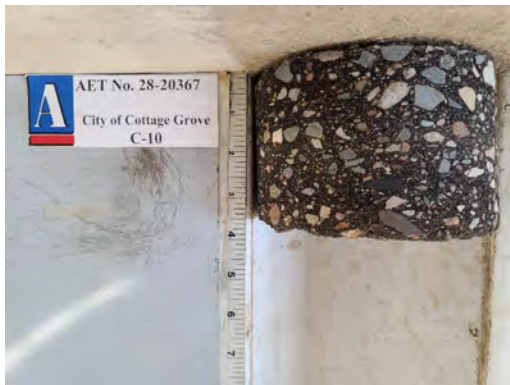
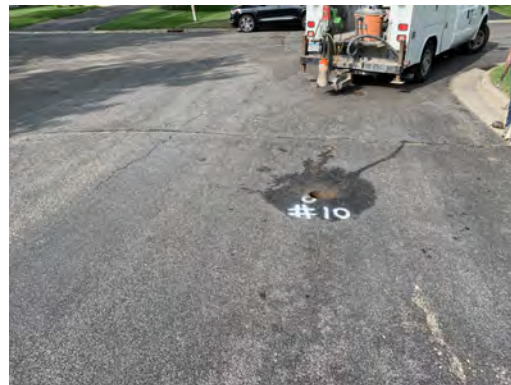
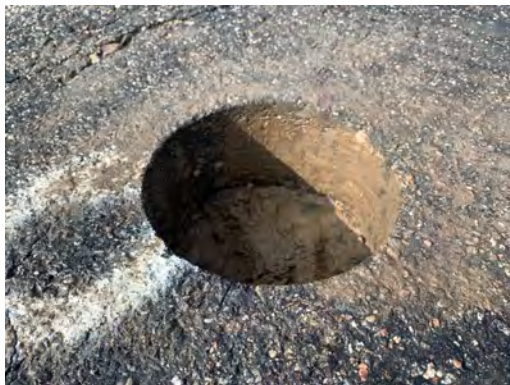
Comments :From surface of core down, Lift 1: 1.5", Lift 2: 2.1". Core generally solid throughout.

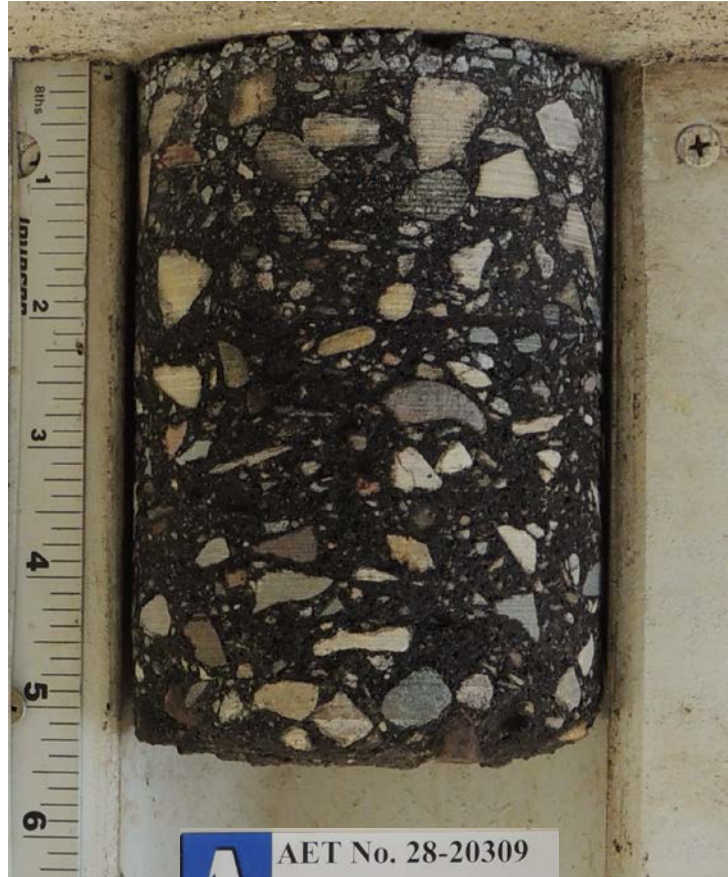
Lift 1 contains slight stripping.

Lifts 2 and 3 contain moderate to severe stripping.

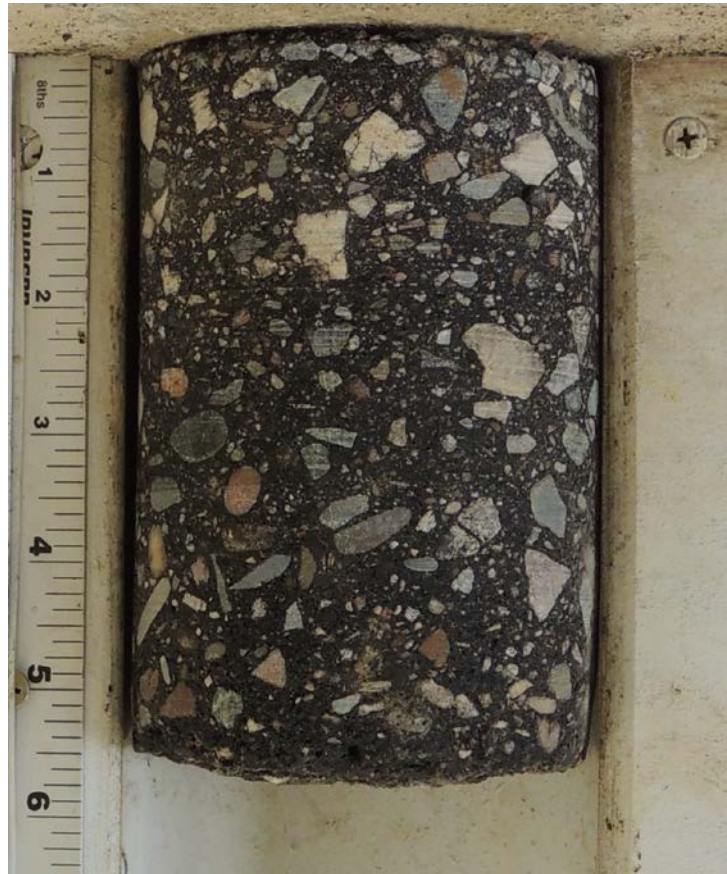
Possible chip seal at the surface.
Lifts 1 and 2 contain slight stripping.
Lift 3 contains moderate stripping.
Bottom of core not recovered.

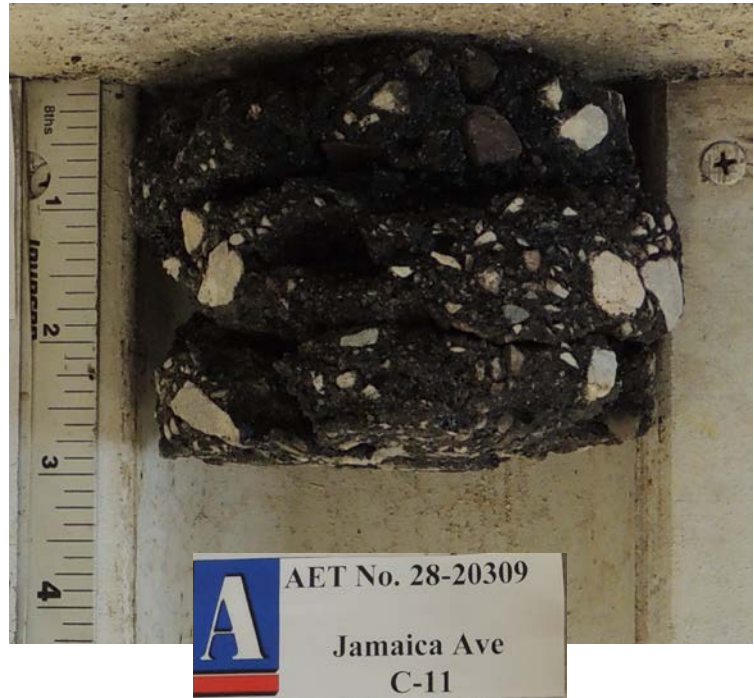
Possible chip seal at the surface.
Core contains severe stripping
throughout. Core crumbled during
coring operations.
